HYUNDAI NEW THINKING. NEW POSSIBILITIES. Technical Service Bulletin	GROUP Driveshaft and Axle	NUMBER 12-DS-002
	DATE MAY 2012	MODEL(S) CM Santa Fe EN Veracruz
SUBJECT: SANTA FE (CM), VERACRUZ (EN) DRIVE SHAFT NOISE

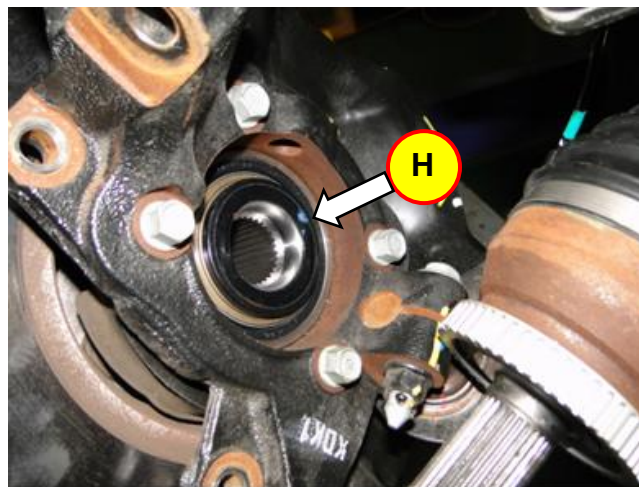
8. Remove and discard the plastic washer (H) from the front axle hub.

9. Install the replacement drive shaft washer (I).

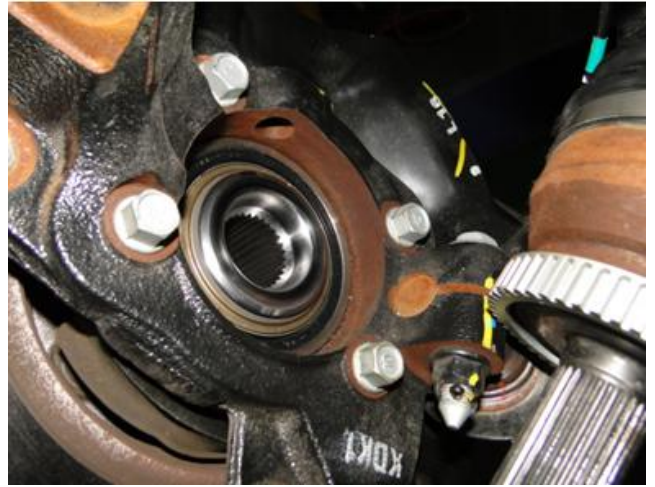
Washer has been removed from the axle hub.
