TSB-Local	Model	Sorento[XM]()
	Group	Engine Electrical System(11)
	TSB No.	KCE11-11-P270-XM;C21VA
Subject Glow Plug and Relay Inspection/Replacement	Published	1/11/2012
	TSB Type	Service Action
	Area & Distributor	U.K (C21VA)

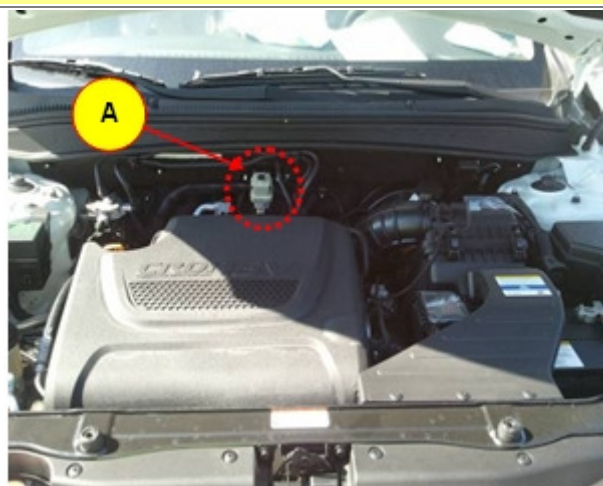
1. Open the hood, and then locate the glow relay (A).

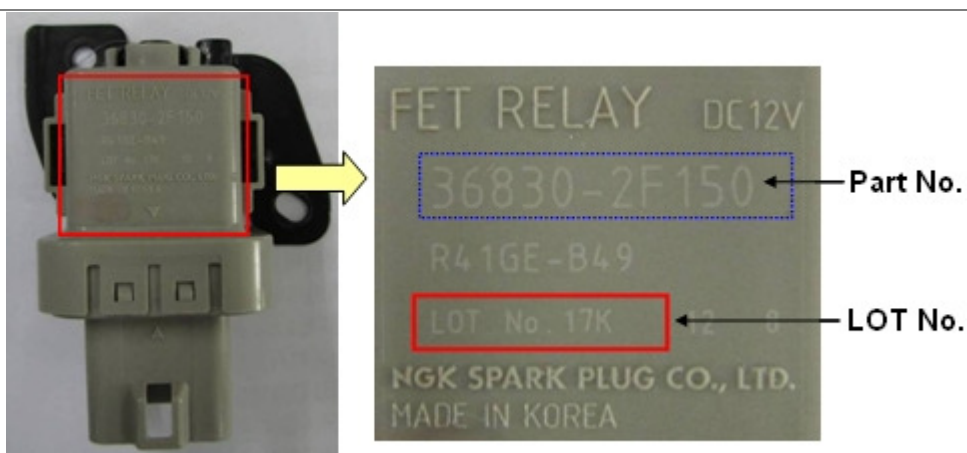
2. Check the LOT No. of the glow relay.
 - 1) Location of LOT No.

2) Following is the affected lot number range.

* **Affected production range : 16B ~ 180 (June 2, 2011 ~ Aug. 20, 2011)**

- 1) Condition 1: The glow relay is an affected one.
 - If the DTC P0684 or P0670 detected, replace the glow relay and 4 glow plugs with new ones following the procedure.
 - But, if no or other DTC detected, replace only the glow relay with a new one.
- 2) Condition 2: The glow relay is not an affected one.
 - If any DTC exists, repair the system according to the applicable workshop
