GROUP Body	MODEL 2011MY Sorento (XM)
	NUMBER 067	DATE July 2010
<h2 style="text-align: center;">TECHNICAL SERVICE BULLETIN</h2>		
SUBJECT: PANORAMA SUNROOF VIBRATION/CHATTER DURING NORMAL OPERATION

**PANORAMA SUNROOF VIBRATION/CHATTER DURING
NORMAL OPERATION**

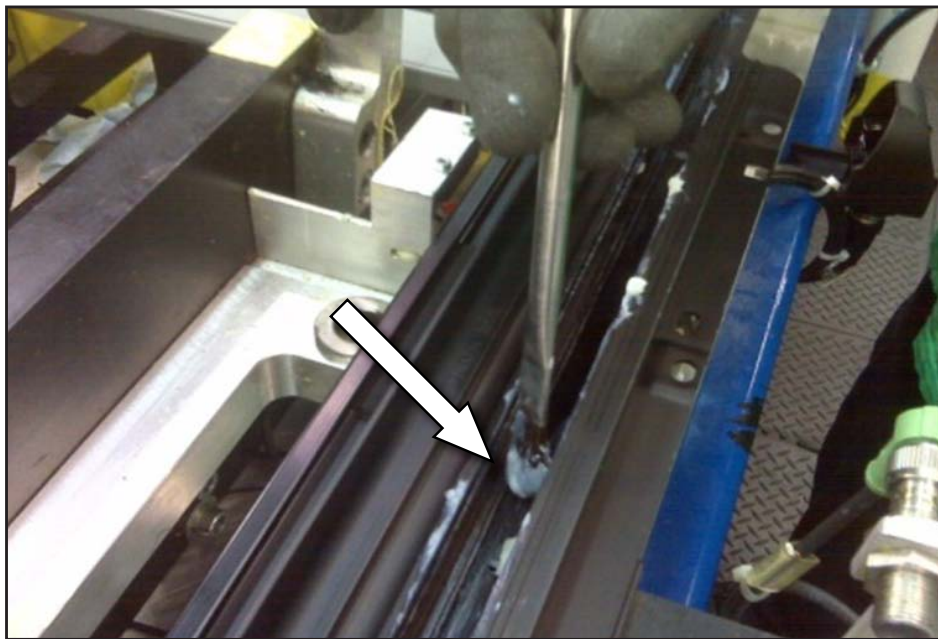
Application of silicone based generic lubricant in the sunroof track channel.

This bulletin provides information relating to some Sorento (XM) vehicles equipped with panoramic sunroof and built from October 23, 2009 to May 24, 2010 that may experience a vibration or chatter noise during normal sunroof operation. The cause for this is a lack of lubrication in both left and right-side sunroof track channels. To improve customer satisfaction Kia is launching this Field Fix to add the proper amount of lubricant to both right and left sunroof track channels to eliminate sunroof vibration and chatter on all affected Kia Sorento (XM) vehicles.

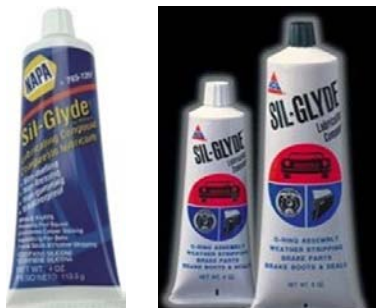
Part Name	Part Number	Figure
Silicone based generic lubricant such as Sil-Glyde.	(NAPA #) 765 1351
