HYUNDAI NEW THINKING. NEW POSSIBILITIES. Technical Service Bulletin	GROUP Driveshaft and Axle	NUMBER 12-DS-002
	DATE MAY 2012	MODEL(S) CM Santa Fe EN Veracruz
SUBJECT: SANTA FE (CM), VERACRUZ (EN) DRIVE SHAFT NOISE

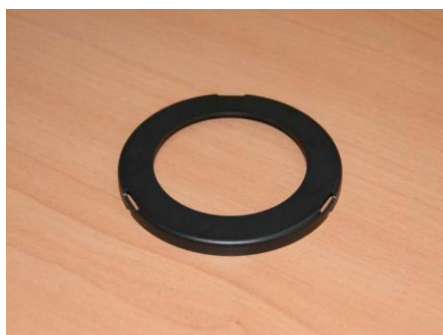
Description: Some customers may report a slight creak or popping noise from the front of the vehicle when accelerating from a stop, either forwards or reverse. This bulletin describes the service procedure to replace the drive shaft washers with revised washers.
